Buffers improve water quality

Recently, the MPCA had a request asking if we could see a difference in water quality in streams from sites where there are buffers compared to sites without buffers.

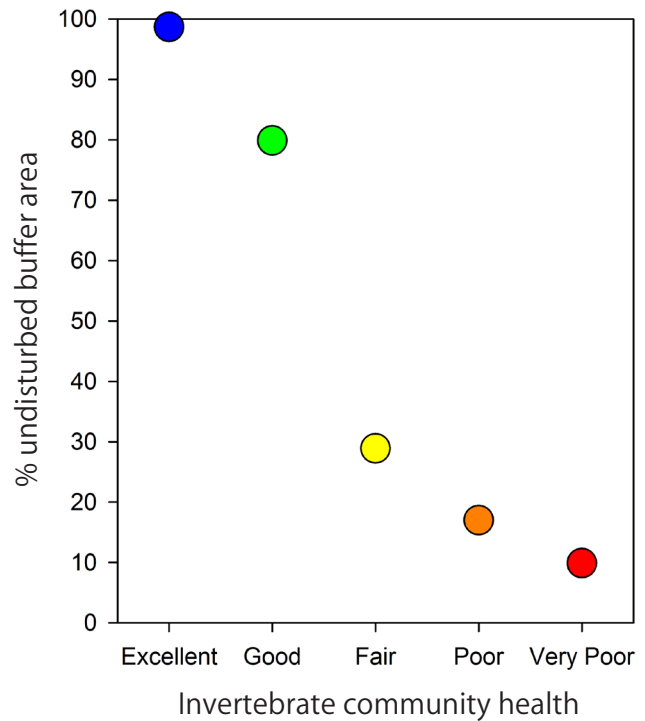
Then we compared the buffer quality to the health of the fish and invertebrate communities at each site. The sites were grouped into “excellent,” “good,” “fair,” “poor,” and “very poor” categories based on the health of the biological community (see graphs).

- More than 85% intact buffers have excellent aquatic life
- About 50% – 85% intact buffers have good aquatic life
- Between 25% – 50% intact buffers have fair aquatic life
- Less than 25% intact buffers have poor or very poor aquatic life.

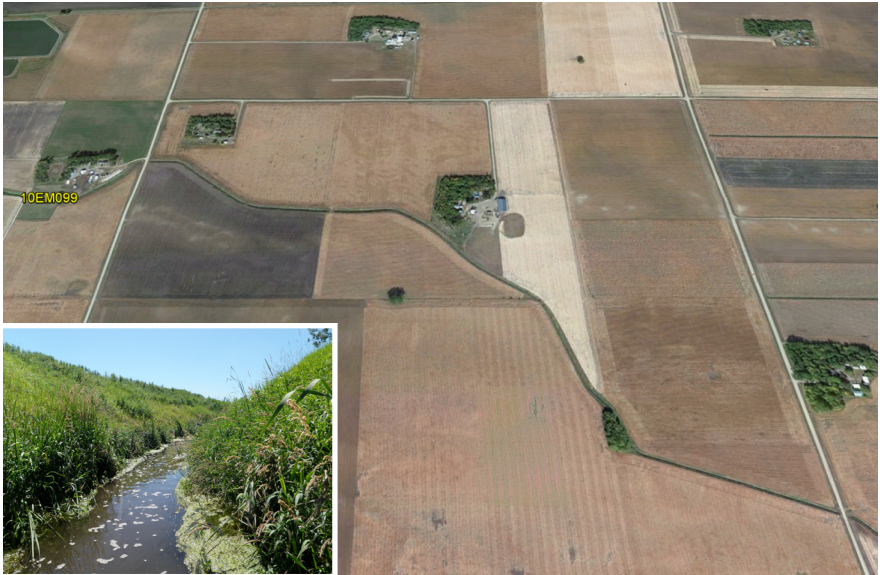
Lower Minnesota River Watershed, County Ditch 13A (channelized stream)

County Ditch 13A is a headwater, channelized tributary to the South Branch of the Rush River in Sibley County. The buffer zone of this stream is in poor condition and dominated by row-crop agriculture. The fish and invertebrate community as well as the in-stream habitat are all severely degraded.

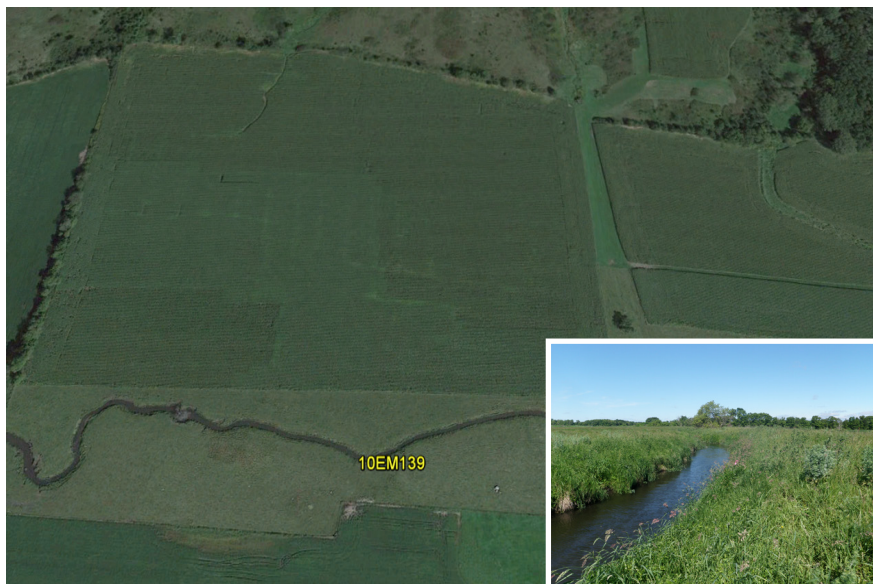
Zumbro River Watershed, North Fork of Zumbro River (channelized stream)

The North Fork of the Zumbro River is a channelized tributary to the Zumbro River in Rice County. The buffer zones of streams in this watershed are generally in poor condition, but the buffer zone around and immediately upstream of the monitoring site is more intact. The fish and invertebrate community reflect the somewhat better habitat conditions at the site.

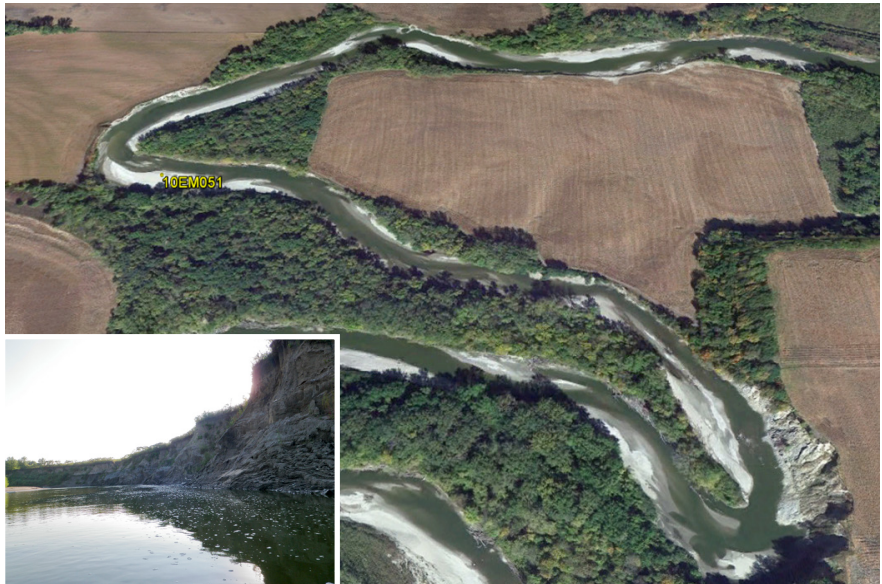
Blue Earth River Watershed, Blue Earth River (natural stream)

The Blue Earth River is a large, direct tributary to the Minnesota River. The buffer zone of this stream’s watershed is often encroached upon by row-crop agriculture. At this monitoring location, the buffer zone around and immediately upstream of the site is somewhat intact, but cropland encroaches on the stream banks in several places and may be contributing to bank erosion along some outside bends. Note the erosion evident in the lower right corner of the air photo and site picture above.

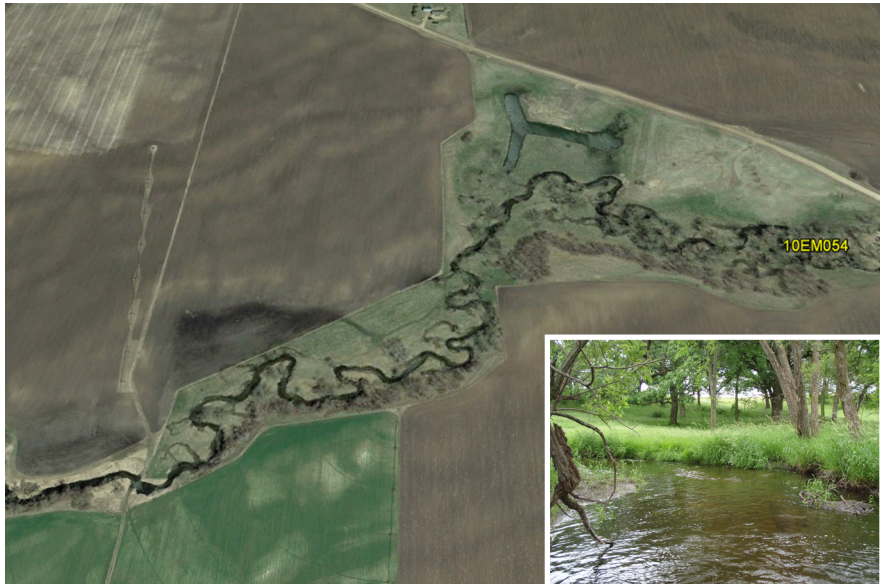
Sauk River Watershed, Silver Creek (natural stream)

Silver Creek is a tributary to the Sauk River in Todd County. The buffer zone at the monitoring site is composed of perennial grasses that may be grazed at times. The stream has good channel development and a stream bottom composed of coarse substrates that are not covered by fine sediments. The intact buffer at this site may somewhat mitigate the impact on the biology of land use practices in the upstream watershed.
